**Initial Report**

**North Central Texas Initial Attack**

**Hildreth Road Dozer Accident**

**February 9, 2006**

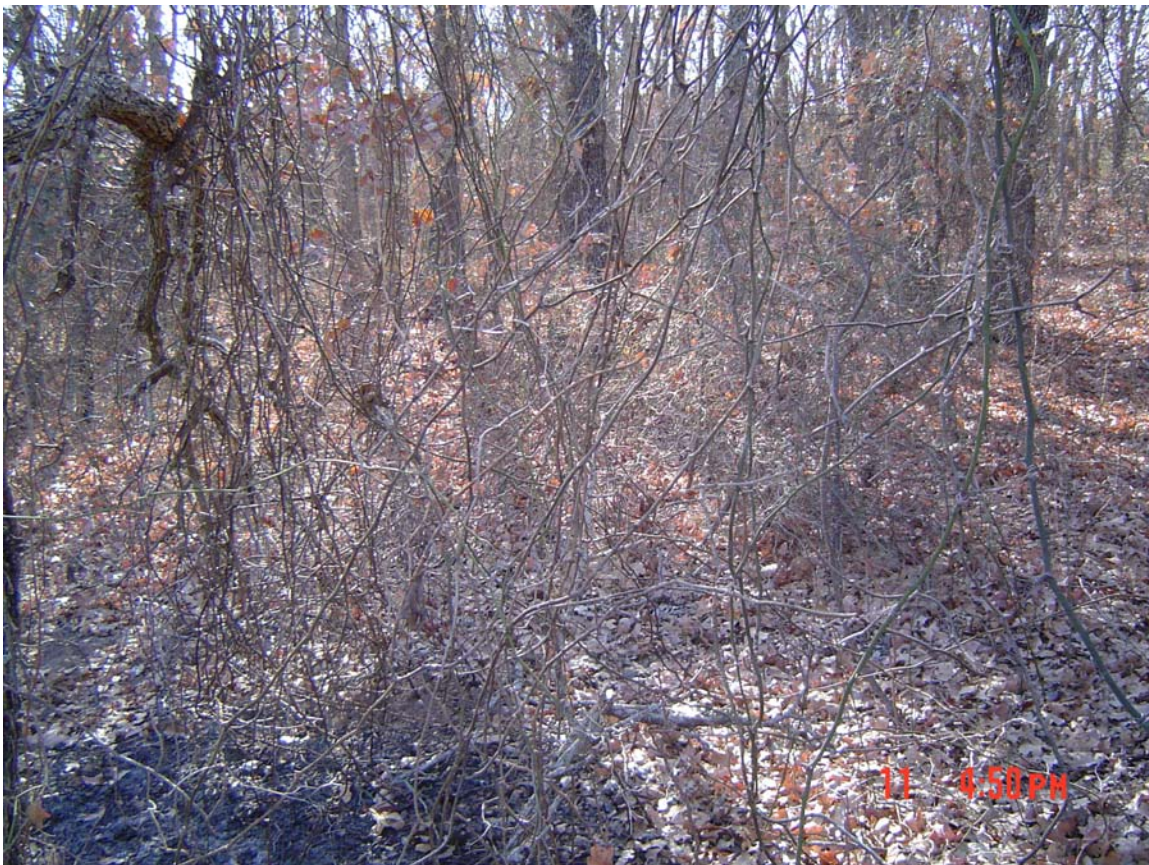
north. Mr. Burns was directing from the front of the dozer through thick brush consisting of post oak, cedar, elm and green briar.

**Photograph showing thickness of the understory vegetation**

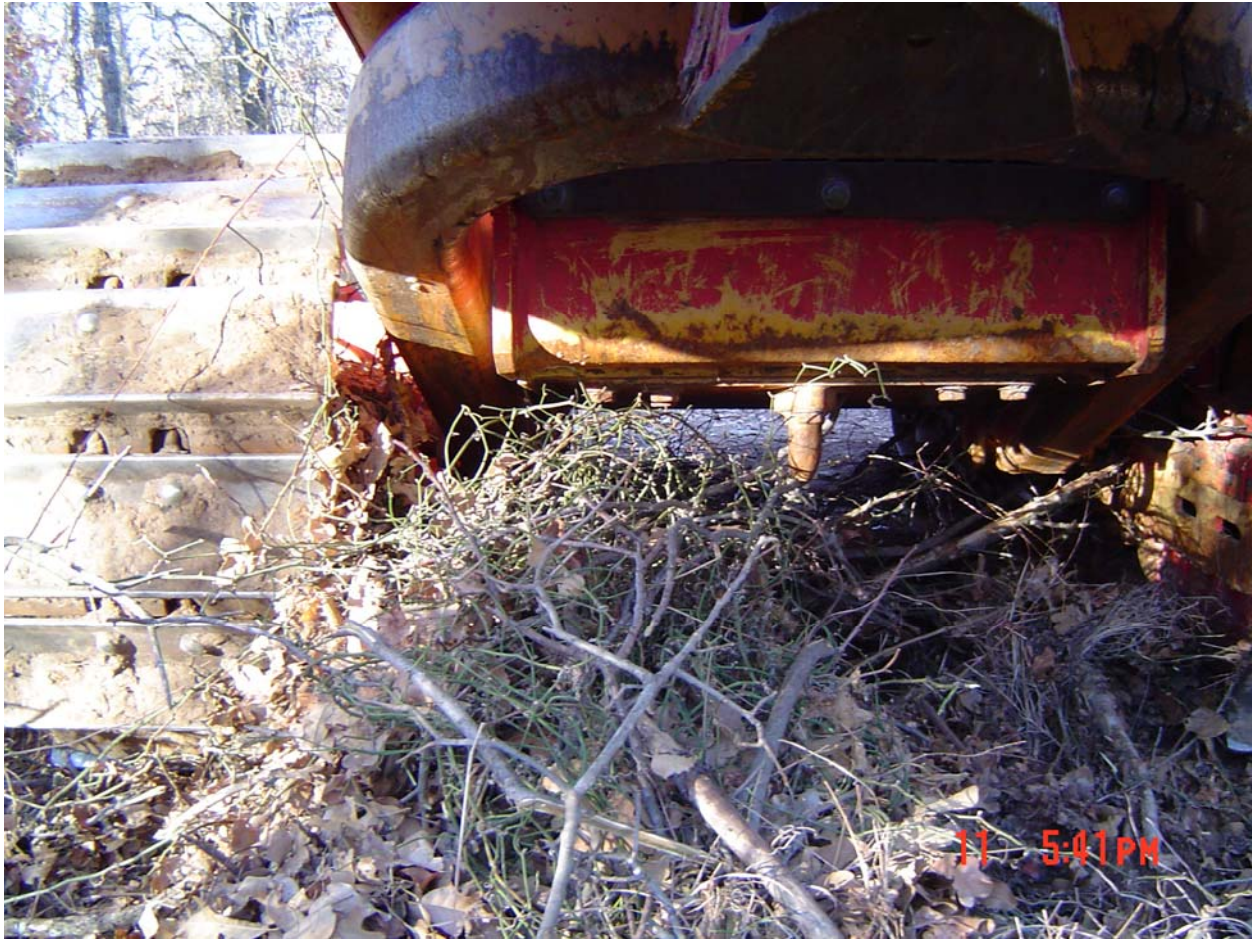
According to witness statements and evidence at the scene, the investigation team concluded that the injured party passed underneath the dozer between the tracks.

Photograph showing clearance under dozer
