GREEN SHEET

**Burn-Over and Shelter Deployment
Nine Injuries
One Fire Engine Destroyed
One Fire Engine with Major Damage**

**July 7, 2007
Inyo Complex
Seven Oak Fire**

**Incident Number CA-INF-000784
Accident Investigation Incident Number CA-CSR-000068**

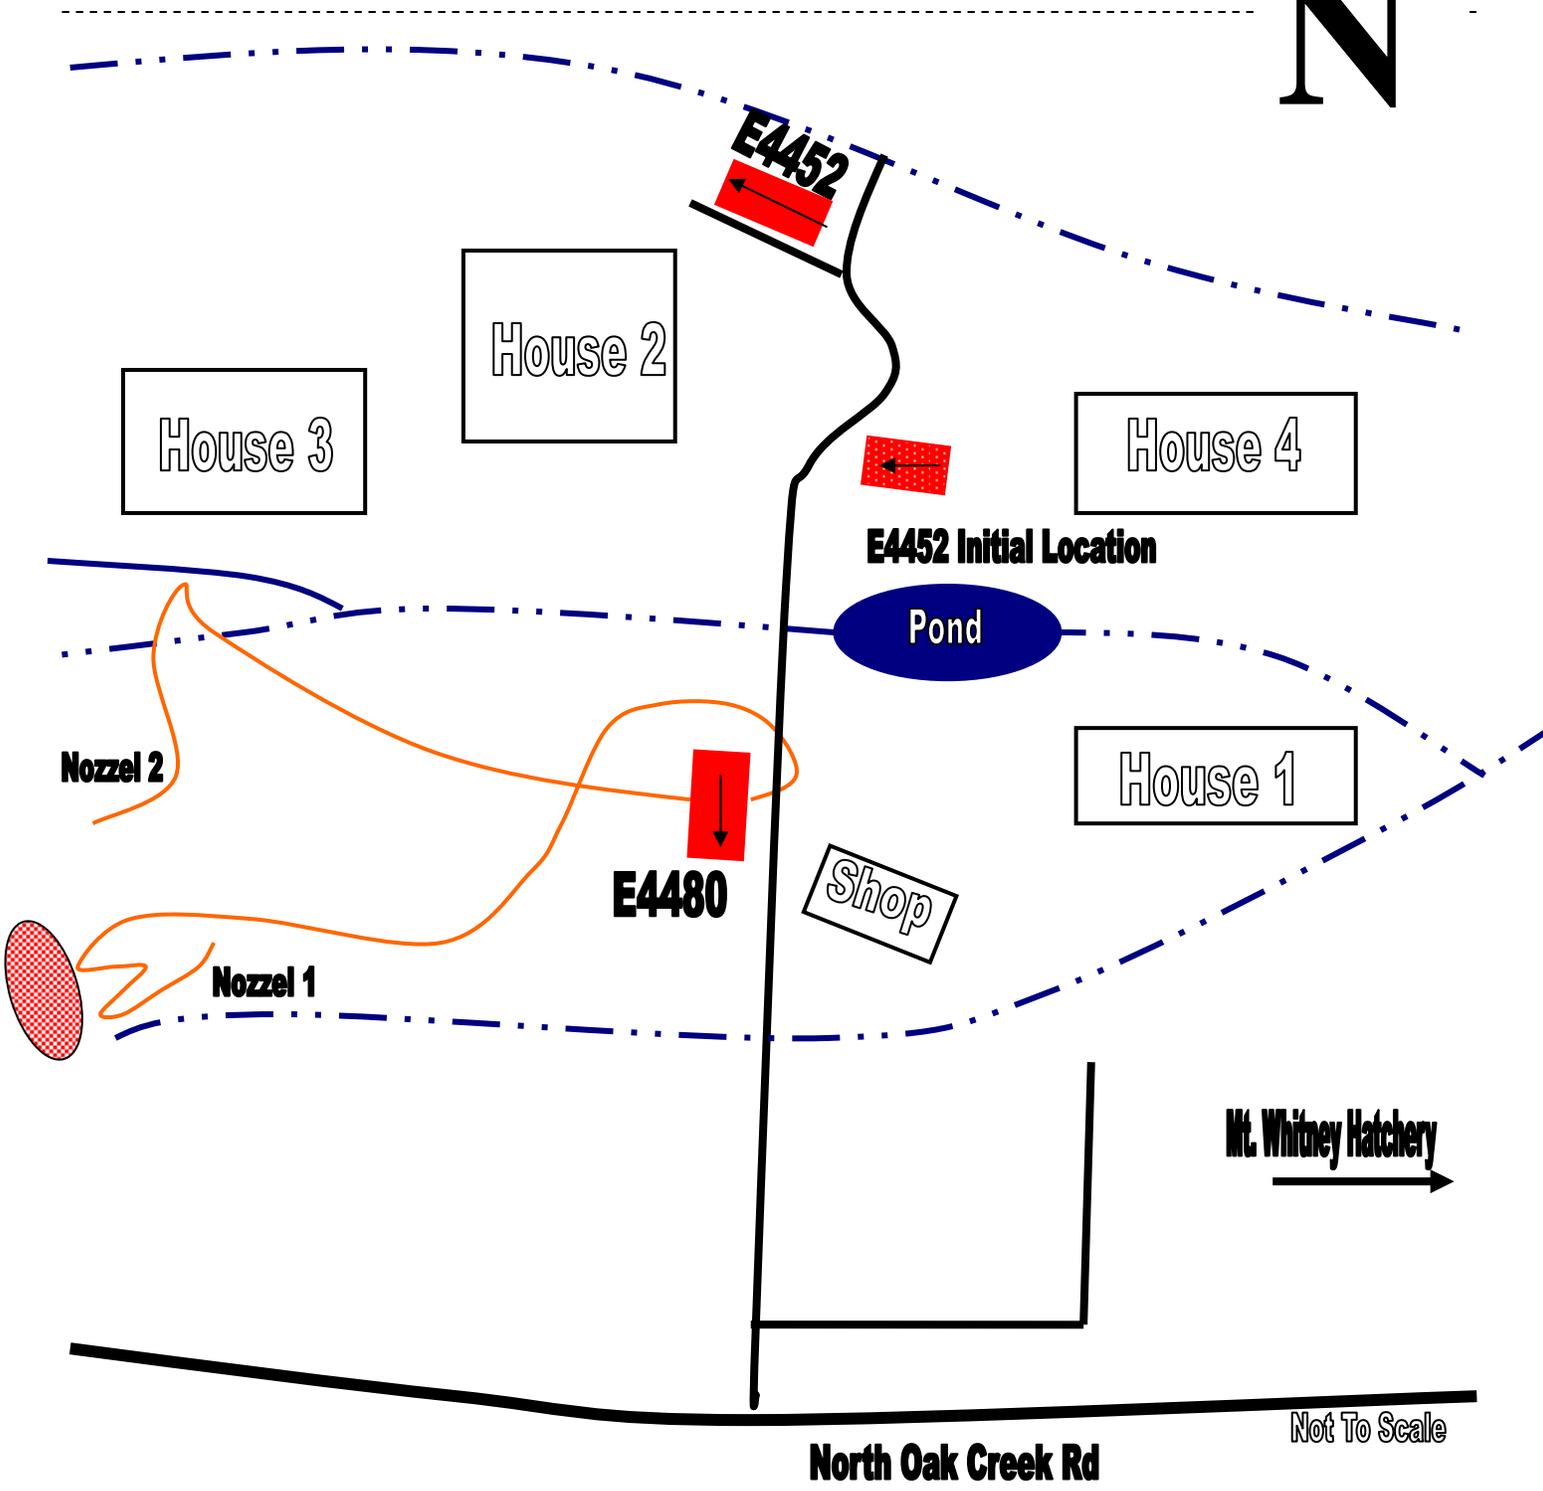
**Hatchery Accident Investigation
Site Map
07/07/2007
Independence, CA**

The LT FAE on E4480 had observed a small pond adjacent to his engine and made it known to all firefighters that this was their safety zone if their position was compromised. However, the Accident Investigation Team has identified the pond as a “REFUGE OF LAST RESORT” meaning the pond does not meet the definition of a “safety zone.” Eventually, their position was compromised and the crews had to retreat to the pond. The crews jumped into the pond, deployed shelters and road out intense heat and fire conditions. Their core training, the
